**Flood Control Project Maintenance
Levee Inspections**

Fall 2018 Levee Maintenance Deficiency Summary Report

Sacramento River Basin

Reclamation District No. 0307 Lisbon

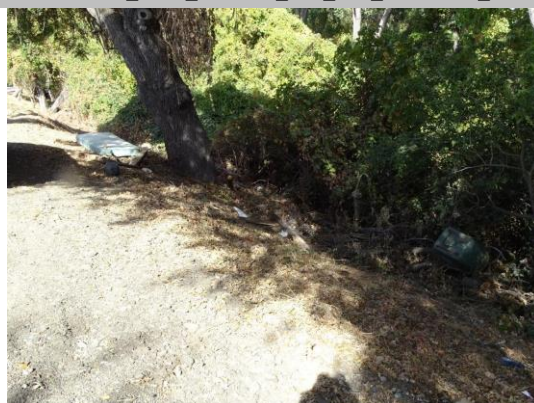
Photo 2 of 2 : FA_2018_RD0307_166_129_20181101_00126.jpg

LM Start	0.14	Rating **	M	Issue No.	129 (cont)
LM End	0.14	Issue Type +	Ma	Location *	WS

View of mattress and other debris on slope. Fall 2018

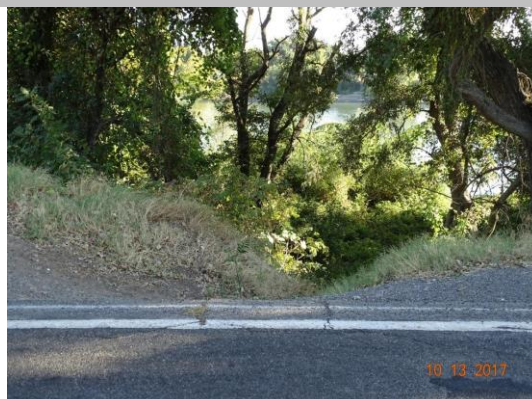
Photo 1 of 1 : FA_2018_RD0307_166_66_20180910_00015.jpg

LM Start	0.20	Rating **	M	Issue No.	66
LM End	0.20	Issue Type +	Ma	Location *	WS
Category	Earthen Levee			GPS Latitude/Longitude	
				Start	End
Item	Slope Stability			38.477977 °	38.477977 °
				-121.546914 °	-121.546914 °
DWR ID	DWR_RD0307_01_f_2017_66				
Comment Code					
S2 : Repair the levee slope damaged by foot traffic and prevent access where possible.					
Inspector Comment					
Foot traffic on waterside slope.

Slope erosion should be repaired and foot traffic stopped.

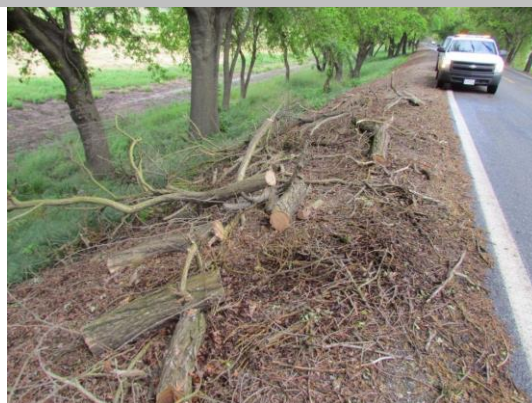
Photo 1 of 1 : FA_2018_RD0307_166_59_20180910_00011.jpg

LM Start	0.35	Rating **	M	Issue No.	59
LM End	0.35	Issue Type +	Ma	Location *	LS
Category	Earthen Levee			GPS Latitude/Longitude	
				Start	End
Item	Encroachments			38.476428 °	38.476428 °
				-121.544955 °	-121.544955 °
DWR ID	DWR_RD0307_01_s_2017_59				
Comment Code					
TR : Tree or limb					
Inspector Comment					
Remove the cut up fallen tree from the landside levee slope and shoulder.

RD 307 Landside slope looking downstream from levee mile 0.35.

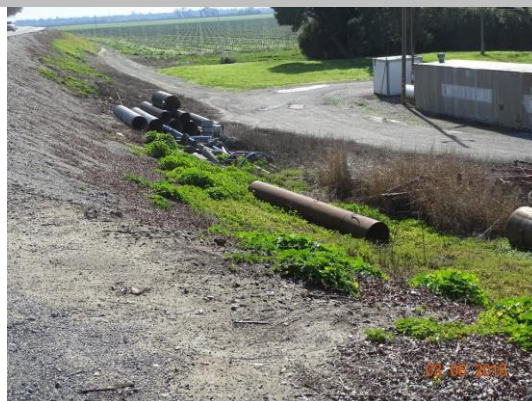
Photo 1 of 1 : FA_2018_RD0307_166_48_20180910_00006.jpg

LM Start	0.58	Rating **	M	Issue No.	48
LM End	0.58	Issue Type +	En	Location *	LS
Category	Earthen Levee			GPS Latitude/Longitude	
				Start	End
Item	Encroachments			38.474543 °	38.474543 °
				-121.541419 °	-121.541419 °
DWR ID	DWR_RD0307_01_s_2018_48				
Comment Code					
EQ : Equipment					
Inspector Comment					
Pipes stored at landside toe.

Encroachment pipes at landside toe looking southeast

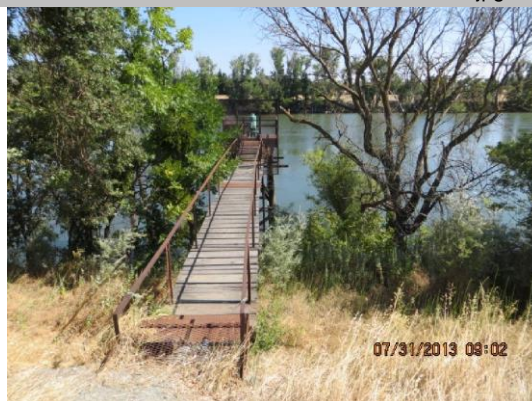
Photo 2 of 3 : UCIP_FA_2018_17103_29201.jpg

LM Start	0.93	Rating **	M	Issue No.	131 (cont)
LM End	0.93	Issue Type +	En	Location *	
Category	Supplemental			GPS Latitude/Longitude	
				Start	End
Item	DWR UCIP Field Study			38.472872 °	38.472872 °
				-121.535542 °	-121.535542 °
DWR ID	24014				
Comment Code					
Inspector Comment					
FS_ID:17103 DS_ID:24014 EP_NO: 18229 Repair Type: Non-Urgent Crossing Status: Found UCIP Comments: Pipe open on both ends. Need to install caps. FIELD_STRUCT_DESC: 2 of 2: 2-inch galvanized iron electrical conduit through the levee, 2 feet below the crown. (Permit No. 18229, 2007 - Albert Martinelli). FS Date: 7/31/2013

Conduit visible under first step of walkway to pump on WS shoulder.

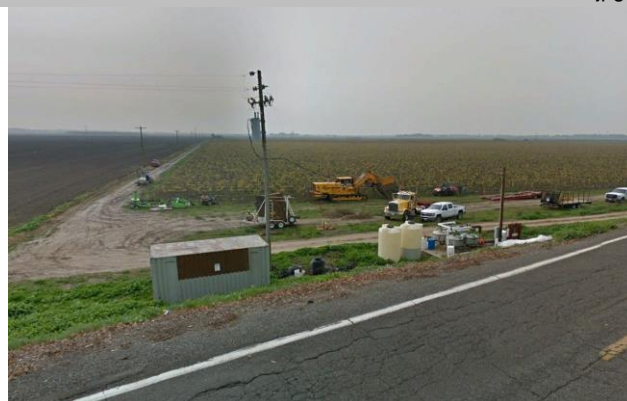
Photo 1 of 1 : FA_2018_RD0307_166_81_20180910_00020.jpg

LM Start	0.94	Rating **	U	Issue No.	81
LM End	0.94	Issue Type +	En	Location *	LS
Category	Earthen Levee			GPS Latitude/Longitude	
				Start	End
Item	Encroachments			38.472838 °	38.472838 °
				-121.535327 °	-121.535327 °
DWR ID	DWR_RD0307_01_f_2017_81				
Comment Code					
EQ : Equipment					
Inspector Comment					
Remove shed and equipment from landside levee toe and 10-foot easement.

10/13/2017: Remove shed and equipment from levee toe and 10-foot easement.

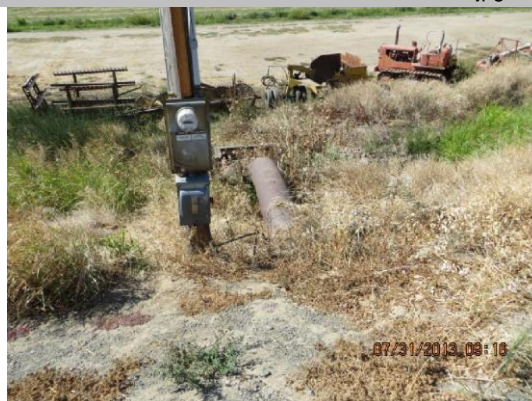
Photo 1 of 3 : UCIP_FA_2018_16764_28764.jpg

Comment Code					
Inspector Comment					
FS_ID:16764					
DS_ID:21659					
EP_NO: 8012					
Repair Type: Non-Urgent					
Crossing Status: Found					
UCIP Comments: Pipe rusted through at outlet on LS of shutoff valve. This may be good indicator or corrosion throughout pipe. This is a good candidate for video inspection.					
FIELD_STRUCT_DESC: 1 of 2: 20-inch steel irrigation pipe through the levee, 7.4 feet below the crown. Walkway from the waterside (WS) shoulder to pump on pile structure in stream. Distribution box and gate valve at the landside (LS) toe. Service pole on the LS. (Permit No. 8012, 1972 - Eula Glide Elliott). [Additional Reference(s): DWR Levee Log, 1990. USACE Sacramento O&M Manual 114, April 1959, (RM 48.53)].					
FS Date: 7/31/2013

Pipe and JP/meter on LS slope.

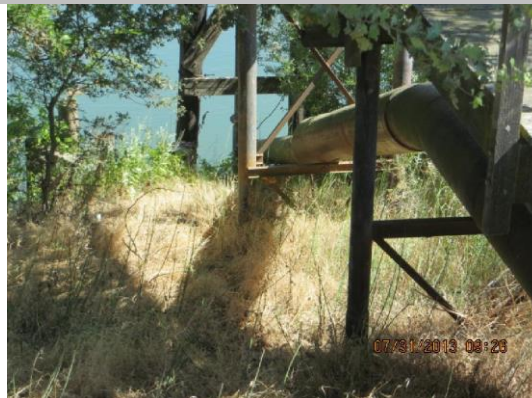
Photo 3 of 3 : UCIP_FA_2018_16764_28762.jpg

Comment Code						
Inspector Comment						
FS_ID:16764						
DS_ID:21659						
EP_NO: 8012						
Repair Type: Non-Urgent						
Crossing Status: Found						
UCIP Comments: Pipe rusted through at outlet on LS of shutoff valve. This may be good indicator or corrosion throughout pipe. This is a good candidate for video inspection.						
FIELD_STRUCT_DESC: 1 of 2: 20-inch steel irrigation pipe through the levee, 7.4 feet below the crown. Walkway from the waterside (WS) shoulder to pump on pile structure in stream. Distribution box and gate valve at the landside (LS) toe. Service pole on the LS. (Permit No. 8012, 1972 - Eula Glide Elliott). [Additional Reference(s): DWR Levee Log, 1990. USACE Sacramento O&M Manual 114, April 1959, (RM 48.53)].						
FS Date: 7/31/2013

Pipe visible under wooden walkway on WS slope.

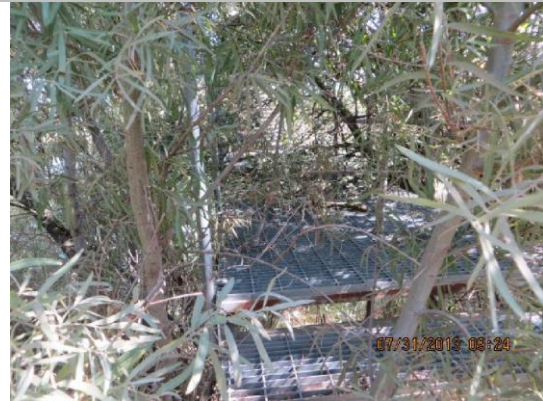
Photo 2 of 3 : UCIP_FA_2018_16766_28768.jpg

LM Start	1.08	Rating **	M	Issue No.	133 (cont)
LM End	1.08	Issue Type +	En	Location *	
Category	Supplemental			GPS Latitude/Longitude	
				Start	End
Item	DWR UCIP Field Study			38.472874 °	38.472874 °
				-121.532611 °	-121.532611 °
DWR ID	21660				
Comment Code					
Inspector Comment					
FS_ID:16766 DS_ID:21660 EP_NO: 3324 Repair Type: Non-Urgent Crossing Status: Found UCIP Comments: Walkway completely obscured by vegetation on WS slope. FIELD_STRUCT_DESC: 1.25-inch electrical conduit of an unknown material through the levee, 10 feet below the crown. Corrugated metal stage recorder house and walkway on the waterside (WS) slope. Service pole on the landside (LS) slope. (Permit No. 3324, 1960 - U.S. Department of the Interior, Surface Water Branch). [Additional Reference(s): DWR Levee Log, 1990]. FS Date: 7/31/2013

Metal walkway visible in brush on WS slope.

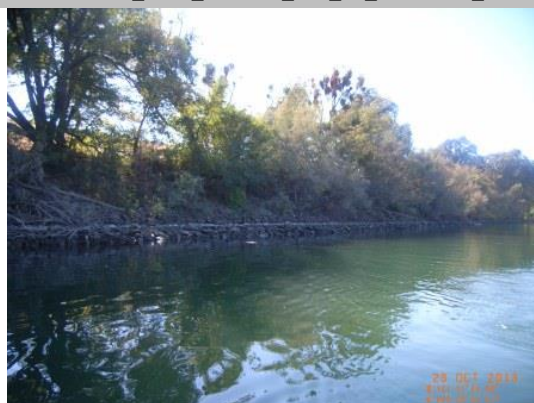
Photo 2 of 2 : FA_2018_RD0307_166_44_20181105_00127.jpg

LM Start	1.14	Rating **	M	Issue No.	44
LM End	1.23	Issue Type +	Ma	Location *	WS
Category	Supplemental			GPS Latitude/Longitude	
				Start	End
Item	2017 USACE Erosion Survey, DRAFT			38.473161 °	38.473103 °
				-121.531474 °	-121.529831 °
DWR ID	DWR_RD0307_01_f_2018_44				
Comment Code					
Inspector Comment					
2017 Site ID: SAC 48.6 R					
Status: Eroding					
2017 Field Notes: Site lengthened upstream and shortened downstream.					
Site History: 2012 - Bank is slowly eroding, old rock protection starting to unravel. 2016 - Anthropogenic erosion observed.

USACE 2013 Photo #1

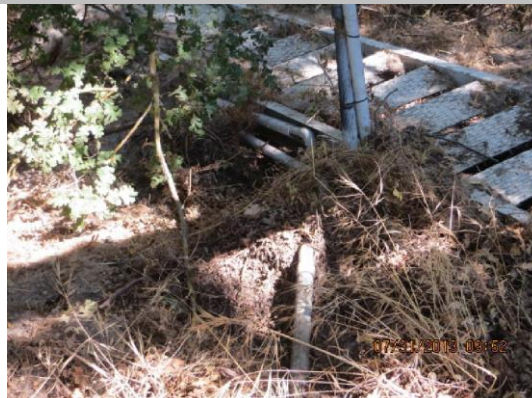
Photo 2 of 3 : UCIP_FA_2018_17105_29206.jpg

LM Start	1.62	Rating **	M	Issue No.	134 (cont)	
LM End	1.62	Issue Type +	En	Location *		
Category	Supplemental			GPS Latitude/Longitude		
				Start	End	
Item	DWR UCIP Field Study			38.473129 °	38.473129 °	
				-121.522717 °	-121.522717 °	
DWR ID	24017					
Comment Code						
Inspector Comment						
FS_ID:17105						
DS_ID:24017						
EP_NO: N/A						
Repair Type: Non-Urgent						
Crossing Status: Found						
UCIP Comments: No permit identified for crossing or boat dock/steel ramp.						
FIELD_STRUCT_DESC: 2 of 2: 1.5-inch polyvinyl chloride (PVC) irrigation pipe through the levee, 2 feet below the crown. Metal walkway and pier on the waterside (WS) slope. Possible pump, filter, and tanks on the landside (LS) slope.						
FS Date: 7/31/2013

Pipes visible on WS shoulder at steel walkway.

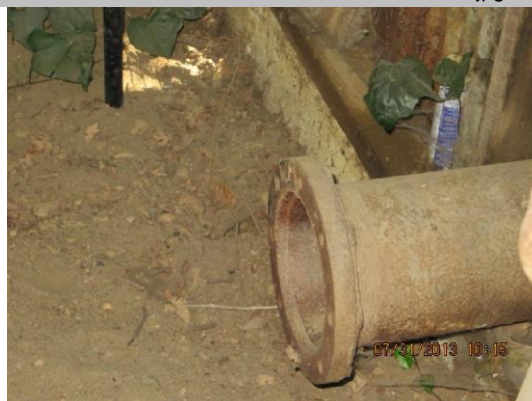
Photo 1 of 2 : UCIP_FA_2018_16805_28806.jpg

Remnants of abandoned pipe visible in pumphouse on LS toe.

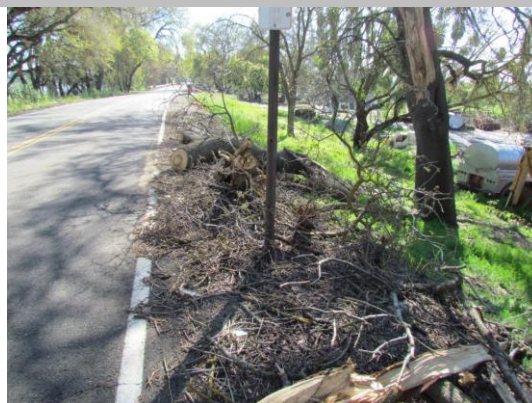
Photo 2 of 3 : FA_2018_RD0307_166_73_20180910_00017.jpg

LM Start	1.86	Rating **	U	Issue No.	73 (cont)	
LM End	1.86	Issue Type +	Ma	Location *	LS	
Category	Earthen Levee			GPS Latitude/Longitude		
				Start	End	
Item	Encroachments			38.473182 °	38.473182 °	
				-121.518280 °	-121.518280 °	
DWR ID	DWR_RD0307_01_s_2016_73					
Comment Code						
TR : Tree or limb						
Inspector Comment						
Remove the cut up oak tree from both ls/ws slops the levee section. No change 4-17.

Looking downstream toward levee mile 1.87 fallen tree on shoulder.

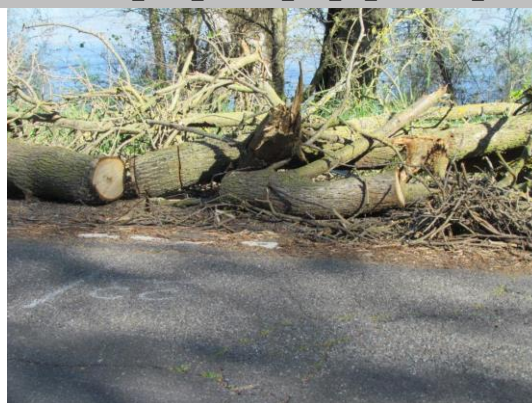
Photo 3 of 3 : FA_2018_RD0307_166_73_20180910_00018.jpg

Waterside shoulder levee mile 1.86 more of the cut up oak.

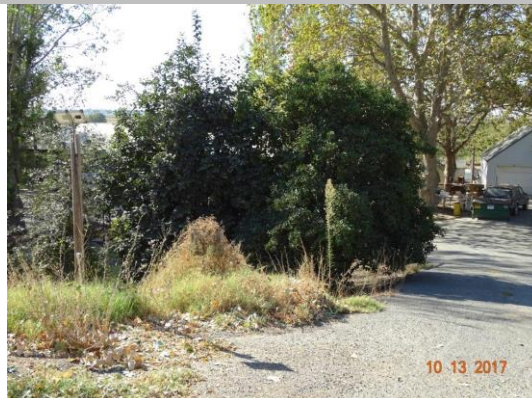
Photo 1 of 1 : FA_2018_RD0307_166_92_20180910_00022.jpg

LM Start	2.22	Rating **	M	Issue No.	92
LM End	2.22	Issue Type +	En	Location *	LS
Category	Earthen Levee			GPS Latitude/Longitude	
				Start	End
Item	Encroachments			38.472155°	38.472155°
				-121.511764°	-121.511764°
DWR ID	DWR_RD0307_01_f_2017_92				
Comment Code					
TR : Tree or limb					
Inspector Comment					
Remove fruit trees on levee slope.

Remove fruit trees on levee slope.

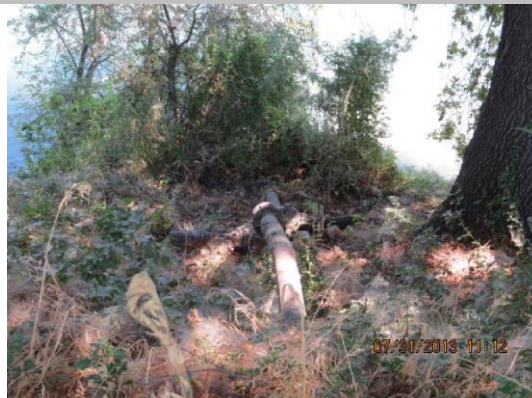
Photo 1 of 3 : UCIP_FA_2018_40794_28823.jpg

Pump and gate valve on WS slope.

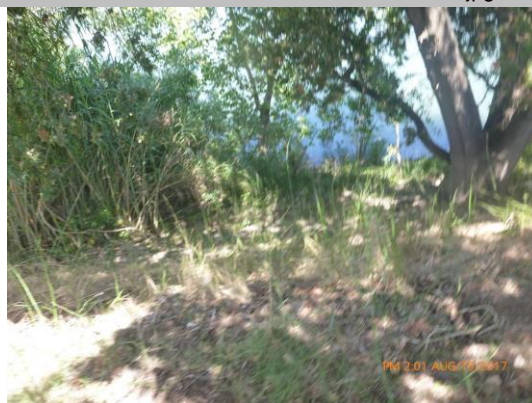
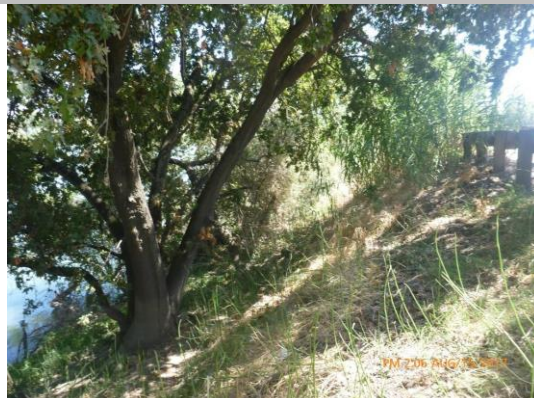
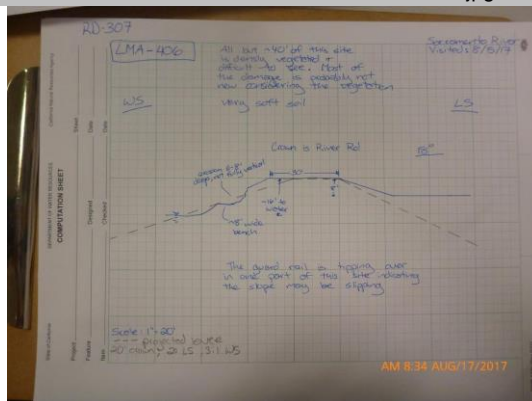
LM Start	2.47	Rating **	M	Issue No.	49
LM End	2.53	Issue Type +	Ma	Location *	
Category	Supplemental			GPS Latitude/Longitude	
				Start	End
Item	2017 Storm Damage			38.470583 °	38.470052 °
				-121.507658 °	-121.506902 °
DWR ID	DWR_RD0307_01_f_2017_49				
Comment Code					
Inspector Comment					
Levee Evaluation Comments					
Description:Slope protection repairs are needed along the waterside slope due to erosion and riprap displacement from high water. Based upon levee inspections, it was determined the waterside levee slope is eroding, deteriorating, and degrading. The eroded levee sections need to be restored back to design standards to prevent further deterioration and damage.					
Site ID No:500					
Site Designation:LMA-406					
Repair Type: Erosion					
Rating:Area of Concern					
Field Date:8/15/2017					
Notes:

LM Start	2.47	Rating **	M	Issue No.	49 (cont)							
LM End	2.53	Issue Type +	Ma	Location *								
Category	Supplemental		GPS Latitude/Longitude									
			Start	End								
Item	2017 Storm Damage		38.470583°	38.470052°								
			-121.507658°	-121.506902°								
DWR ID	DWR_RD0307_01_f_2017_49											
Comment Code												
Inspector Comment												
Levee Evaluation Comments Description: Slope protection repairs are needed along the waterside slope due to erosion and riprap displacement from high water. Based upon levee inspections, it was determined the waterside levee slope is eroding, deteriorating, and degrading. The eroded levee sections need to be restored back to design standards to prevent further deterioration and damage. Site ID No: 500 Site Designation: LMA-406 Repair Type: Erosion Rating: Area of Concern Field Date: 8/15/2017 Notes:

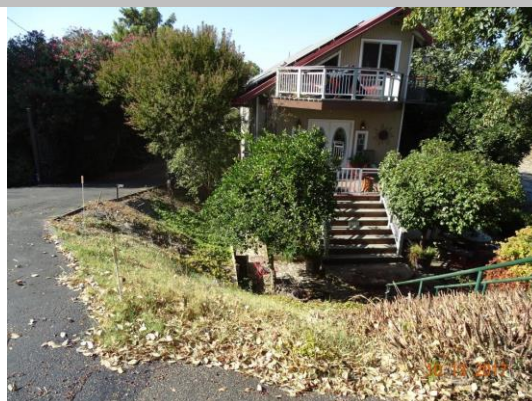
Photo 1 of 1 : FA_2018_RD0307_166_96_20180910_00025.jpg

LM Start	2.59	Rating **	M	Issue No.	96
LM End	2.59	Issue Type +	En	Location *	LS
Category	Earthen Levee			GPS Latitude/Longitude	
				Start	End
Item	Encroachments			38.469358 °	38.469358 °
				-121.506362 °	-121.506362 °
DWR ID	DWR_RD0307_01_f_2017_96				
Comment Code					
TR : Tree or limb					
Inspector Comment					
Remove fruit tree.

Remove fruit tree.

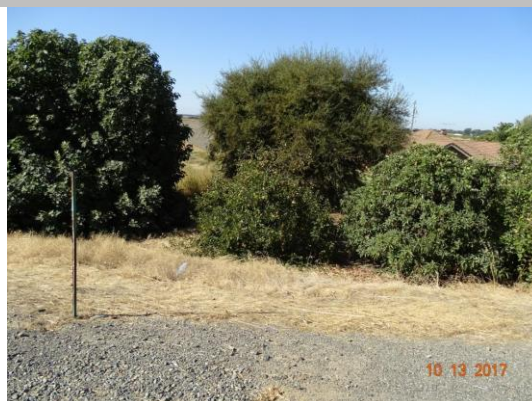
Photo 1 of 1 : FA_2018_RD0307_166_98_20180910_00026.jpg

LM Start	2.64	Rating **	M	Issue No.	98
LM End	2.64	Issue Type +	En	Location *	LS
Category	Earthen Levee			GPS Latitude/Longitude	
				Start	End
Item	Encroachments			38.468547 °	38.468547 °
				-121.506027 °	-121.506027 °
DWR ID	DWR_RD0307_01_f_2017_98				
Comment Code					
TR : Tree or limb					
Inspector Comment					
Remove fruit trees.

Remove fruit trees.

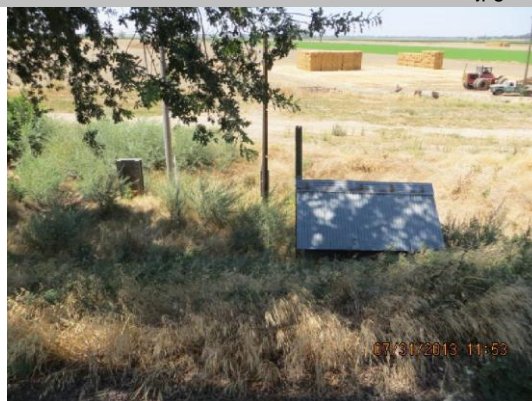
Photo 1 of 2 : UCIP_FA_2018_16815_28850.jpg

Pumphouse on LS toe.

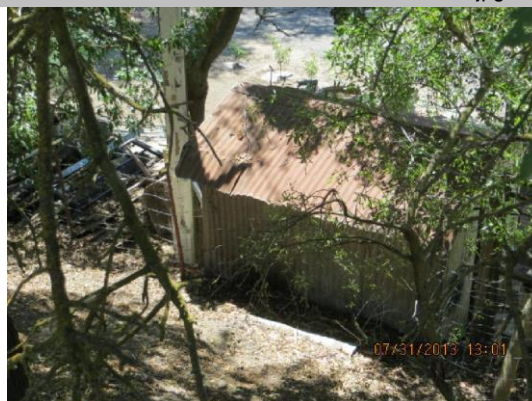
Photo 1 of 2 : UCIP_FA_2018_16843_28881.jpg

Pumphouse on LS toe. No access due to fence along toe.

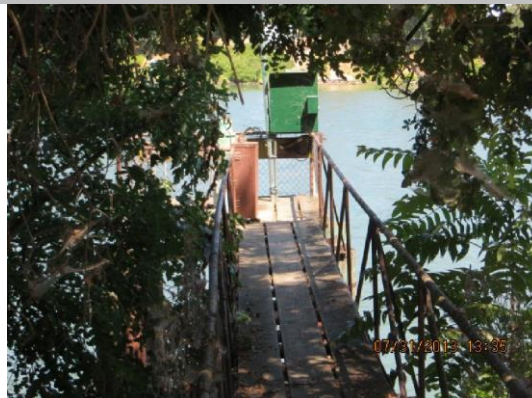
Photo 2 of 3 : UCIP_FA_2018_16924_28981.jpg

Comment Code						
Inspector Comment						
FS_ID:16924 DS_ID:21680 EP_NO: 8030 Repair Type: Non-Urgent Crossing Status: Found UCIP Comments: Pipe not visible on LS slope or toe due to excessive vegetation. Vegetation should be cleared from pipe. FIELD_STRUCT_DESC: 1 of 2: 12-inch steel irrigation pipe through the levee, 6 feet below the crown. Walkway on the waterside (WS) slope to a pump on a pile structure in the stream. Joint pole (JP) and meter on the landside (LS) toe. Pipe appears to cross the levee at an angle. (Permit No. 8030, 1972 - Robert and Hazel Kirkland). [Additional Reference(s): DWR Levee Log, 1990. USACE Sacramento O&M Manual 114, April 1959, (RM 45.92)]. FS Date: 7/31/2013

Pump and electrical controls on Pier at WS slope.

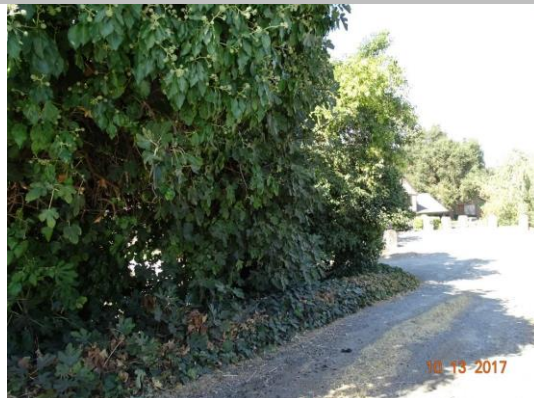
Photo 1 of 1 : FA_2018_RD0307_166_109_20180910_00030.jpg

LM Start	3.86	Rating **	M	Issue No.	109
LM End	3.86	Issue Type +	En	Location *	LS
Category	Earthen Levee			GPS Latitude/Longitude	
				Start	End
Item	Vegetation			38.451239 °	38.451239 °
				-121.502636 °	-121.502636 °
DWR ID	DWR_RD0307_01_f_2017_109				
Comment Code					
V6 : Landscaping					
Inspector Comment					
Trim and thin landscaping to allow inspection and access to landside levee slope and toe.

Trim and thin landscaping to allow inspection and access to landside levee slope and toe.

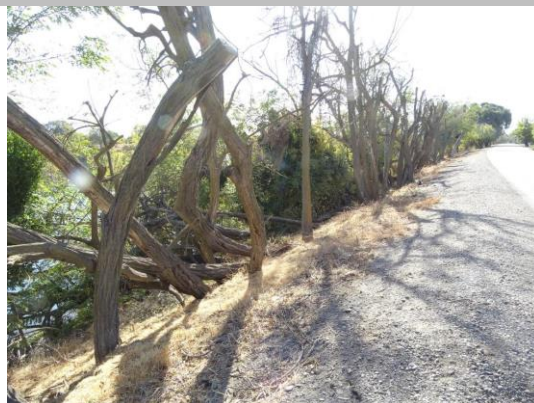
Photo 1 of 1 : FA_2018_RD0307_166_24_20181101_00122.jpg

LM Start	3.86	Rating **	M	Issue No.	24
LM End	3.86	Issue Type +	Ma	Location *	WS
Category	Earthen Levee			GPS Latitude/Longitude	
				Start	End
Item	Encroachments			38.451123 °	38.451123 °
				-121.502622 °	-121.502622 °
DWR ID	DWR_RD0307_01_f_2014_24				
Comment Code					
TR : Tree or limb					
Inspector Comment					
Remove the cut tree limbs from the waterside shoulder.

View of tree limbs on levee slope. Fall 2018

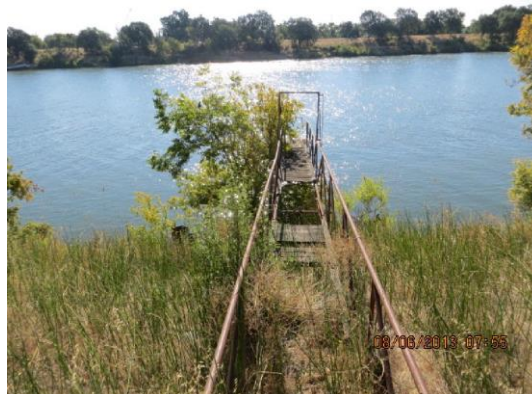
Photo 1 of 3 : UCIP_FA_2018_53338_29022.jpg

UCIP Comments: 06/05/2018 Same as last inspection, Abandoned. Officially downgrading to Non-Urgent (D. Sanoski - DWR UCIP). 12/07/2016 Crossing has been downgraded from Urgent to Non-Urgent pipe appears abandoned. Need to coordinate with owner to determine status of crossing. If crossing is abandoned, owner will need to coordinate with the CVFPB to comply with Title 23. (O. Magana - DWR UCIP) 08/06/2013 Appears abandoned and should be done so properly. Walkway to pier is falling apart and is an attractive nuisance. Pipe rusted through at riser on LS toe. (W. Wylie - DWR UCIP)

Metal walkway to pump on pier and gate valve actuator on WS slope.

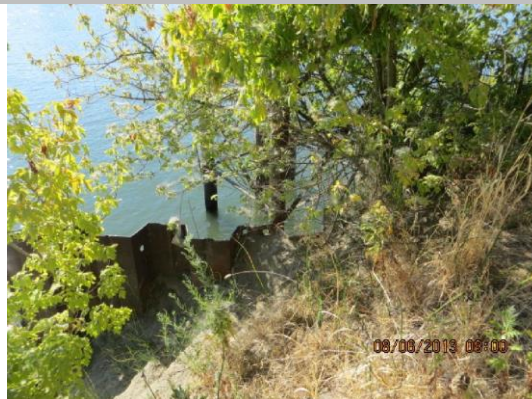
Photo 2 of 3 : UCIP_FA_2018_53338_29021.jpg

Sheet pile wall at WS toe.

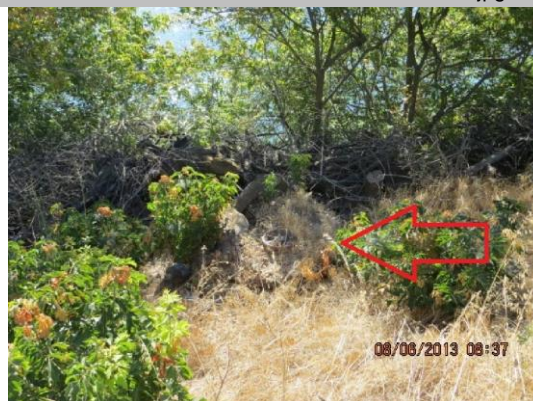
Photo 1 of 3 : UCIP_FA_2018_53339_29261.jpg

FS_ID:53339
DS_ID:21684
EP_NO: 8038
Repair Type: Non-Urgent
Crossing Status: Found
UCIP Comments: 06/05/2018 Same as last inspection; appears abandoned and is being downgraded to Non-Urgent from Urgent because no integrity issues were observed during inspection (D. Sanoski - DWR UCIP).12/07/2016 same as last inspection. Need to coordinate with owner to determine pipe status. If crossing is abandoned, owner will need to coordinate with the CVFPB to comply with Title 23. (O. Magana - DWR UCIP)07/31/2013 Wooden lid on 5-foot Diam. CMP riser rotten and could collapse. This could create a hazard for the public and should be replaced. Pipe appears abandoned and should be done so properly. (W. Wylie - DWR UCIP)
FIELD_STRUCT_DESC: 6-inch steel irrigation pipe through the levee, 13.5 feet below the crown. Gate valve in 5-foot diameter corrugated metal pipe (CMP) riser located on the waterside (WS) slope. Power pole and meter located on the landside (LS) toe (6-inch pipe first referenced in the USACE O&M Manual and later pipe authorized under Automatic Board Order (ABO) issued as Permit No. 8038, 1972 - King).

Wooden lid at gate valve in CMP riser on WS slope.

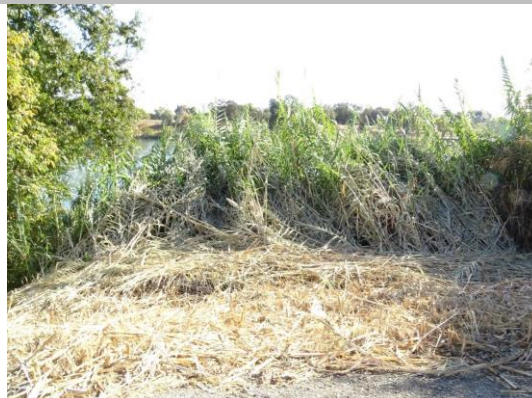
Photo 1 of 1 : FA_2018_RD0307_166_78_20181101_00121.jpg

LM Start	4.08	Rating **	A/W	Issue No.	78
LM End	4.08	Issue Type +	Ma	Location *	WS
Category	Earthen Levee			GPS Latitude/Longitude	
				Start	End
Item	Vegetation			38.448038 °	38.448038 °
				-121.502638 °	-121.502638 °
DWR ID	DWR_RD0307_01_f_2018_78				
Comment Code					
V2 : Remove the wild growth other than native grasses from the levee slopes.					
Inspector Comment					
Monitor arundo on levee slope.

View of arundo on levee slope. Fall 2018

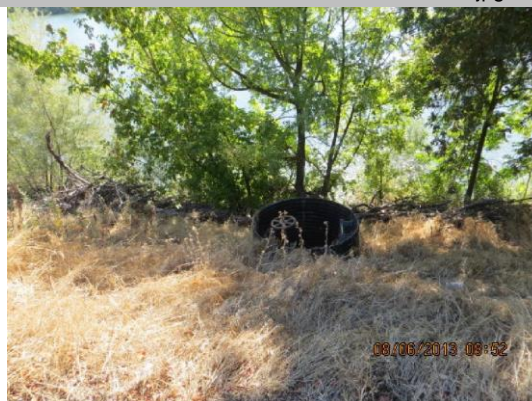
Photo 1 of 3 : UCIP_FA_2018_22670_38290.jpg

Slide gate in riser on WS slope.

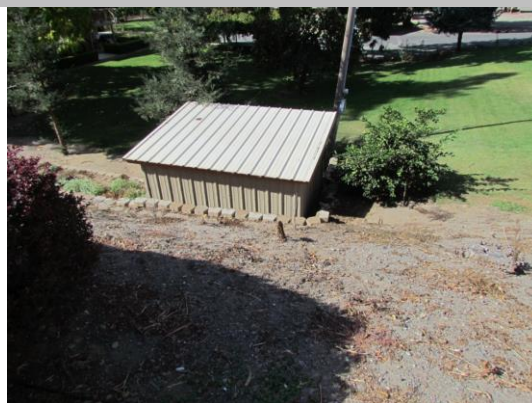
Photo 1 of 1 : FA_2018_RD0307_166_26_20180910_00004.jpg

LM Start	4.31	Rating **	U	Issue No.	26
LM End	4.31	Issue Type +	En	Location *	LS
Category	Earthen Levee			GPS Latitude/Longitude	
				Start	End
Item	Encroachments			38.444612 °	38.444612 °
				-121.503100 °	-121.503100 °
DWR ID	DWR_RD0307_01_f_2014_26				
Comment Code					
BU : Building					
Inspector Comment					
This pumphouse was built without a permit, the district is aware of the encroachment.

This pump house was built without CVFPB Permit.

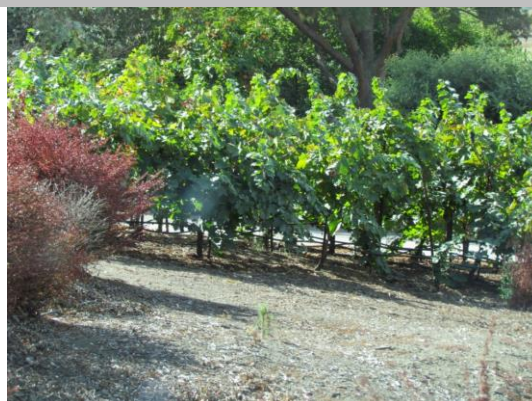
Photo 1 of 1 : FA_2018_RD0307_166_27_20180910_00005.jpg

LM Start	4.39	Rating **	U	Issue No.	27
LM End	4.39	Issue Type +	En	Location *	LS
Category	Earthen Levee			GPS Latitude/Longitude	
				Start	End
Item	Encroachments			38.443517 °	38.443517 °
				-121.503338 °	-121.503338 °
DWR ID	DWR_RD0307_01_f_2014_27				
Comment Code					
CR : Crops					
Inspector Comment					
There are grapes planted on the levee slope landside without permit from the CVFPB. This issue has been reported and recorded in previous inspections.

Unwanted grapes placed on levee slope, these grapes has been reported to both district and CVFPB. No permit.

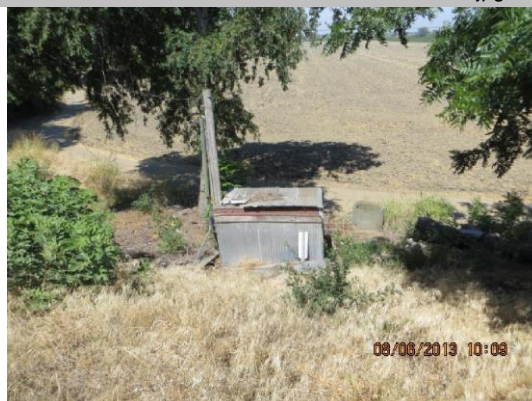
Photo 1 of 3 : UCIP_FA_2018_17183_29321.jpg

Comment Code					
Inspector Comment					
FS_ID:17183					
DS_ID:21690					
EP_NO: 8041					
Repair Type: Non-Urgent					
Crossing Status: Found					
UCIP Comments: Pipe appears abandoned and should be done so properly. Gate valve has been removed from pipe on LS toe.					
FIELD_STRUCT_DESC: 6-inch steel irrigation pipe through the levee, 13.5 feet below the crown. Pump and gate valve in pump house on the landside (LS) slope. Gate valve on the waterside (WS) slope. Service pole and anchor on the LS slope. (Permit No. 8041, 1972 - Albert and Genevieve Fonts). [Additional Reference(s): DWR Levee Log, 1990. USACE Sacramento O&M Manual 114, April 1959, (RM 45.11)].					
FS Date: 8/6/2013

Pumphouse for 6-inch pipe at LS toe.

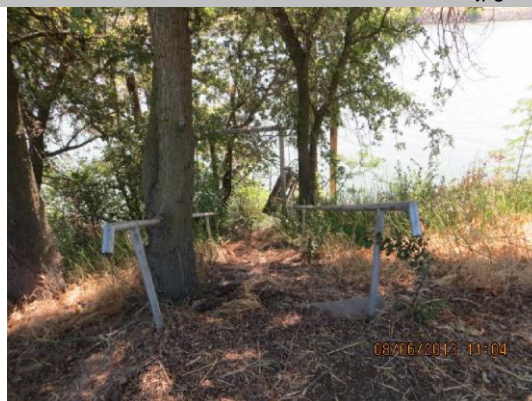
Photo 1 of 3 : UCIP_FA_2018_17184_29326.jpg

Pipe and gate valve on WS slope just downstream from stairs.

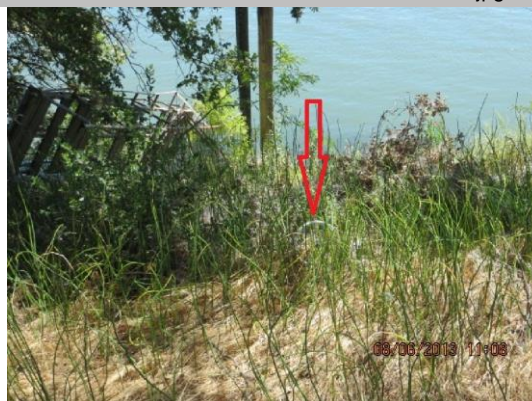
Photo 3 of 3 : UCIP_FA_2018_17184_29324.jpg

Comment Code						
Inspector Comment						
FS_ID:17184						
DS_ID:21691						
EP_NO: 8561						
Repair Type: Non-Urgent						
Crossing Status: Found						
UCIP Comments: Pipe abandoned and should be done so properly.						
Gate valve on LS toe broken.						
FIELD_STRUCT_DESC: 10-inch steel irrigation pipe through the levee,

Gate valve actuator on WS slope.

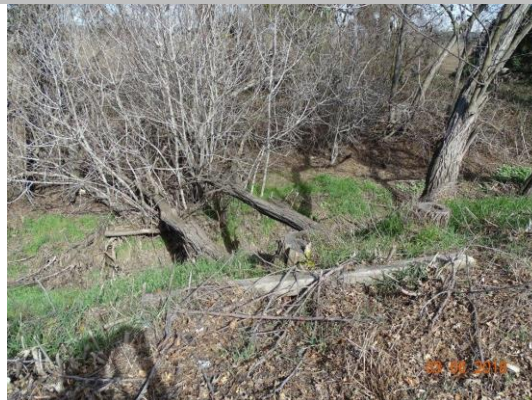
Photo 1 of 1 : FA_2018_RD0307_166_104_20180910_00027.jpg

LM Start	4.88	Rating **	M	Issue No.	104
LM End	4.88	Issue Type +	Ma	Location *	LS
Category	Earthen Levee			GPS Latitude/Longitude	
				Start	End
Item	Encroachments			38.437871 °	38.437871 °
				-121.508356 °	-121.508356 °
DWR ID	DWR_RD0307_01_s_2018_104				
Comment Code					
TR : Tree or limb					
Inspector Comment					
Downed tree on landside slope.

Encroachment downed tree on landside looking south

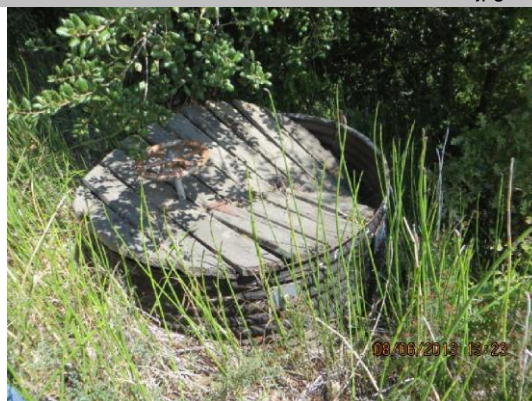
Photo 1 of 3 : UCIP_FA_2018_22710_38415.jpg

Gate valve in 5-foot diameter CMP riser on WS slope.

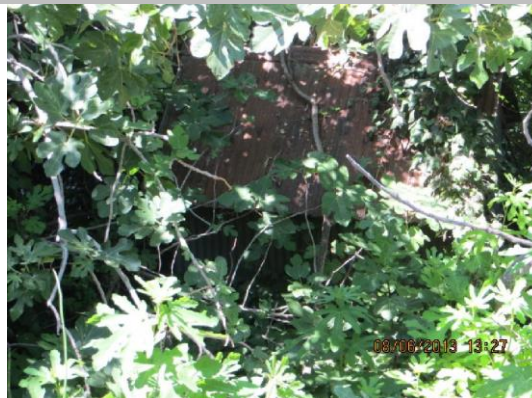
Photo 3 of 3 : UCIP_FA_2018_22710_38413.jpg

Comment Code						
Inspector Comment						
FS_ID:22710						
DS_ID:21698						
EP_NO: 8048						
Repair Type: Non-Urgent						
Crossing Status: Found						
UCIP Comments: Pipe appears abandoned and should be done so properly.						
FIELD_STRUCT_DESC: 6-inch steel irrigation pipe through the levee, 14.5 feet below the crown. Gate valve in a 5-foot-diameter corrugated metal pipe (CMP) riser on the waterside (WS) slope. Pump and gate valve in pump house on the landside (LS) toe. 36-inch concrete standpipe on the LS of the pump house. (Permit No. 8048, 1972 - John Rose). [Additional Reference(s): DWR Levee Log, 1990. USACE Sacramento O&M Manual 114, April 1959, (RM 44.33)].						
FS Date: 8/6/2013

Pumphouse on LS toe.

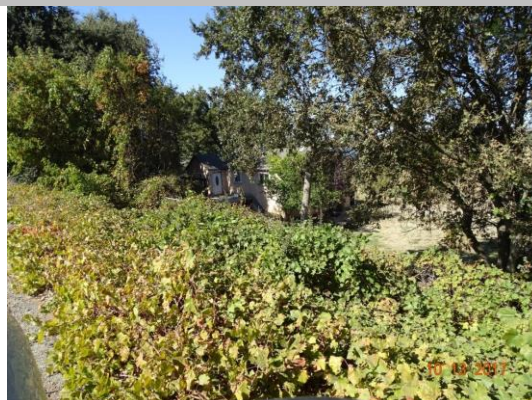
Photo 1 of 1 : FA_2018_RD0307_166_121_20180910_00033.jpg

LM Start	5.23	Rating **	U	Issue No.	121
LM End	5.28	Issue Type +	En	Location *	LS
Category	Earthen Levee			GPS Latitude/Longitude	
				Start	End
Item	Vegetation			38.435926 °	38.435788 °
				-121.514241 °	-121.515092 °
DWR ID	DWR_RD0307_01_f_2017_121				
Comment Code					
V6 : Landscaping					
Inspector Comment

Trim and thin landscaping to allow inspection and access to landside levee slope and toe.

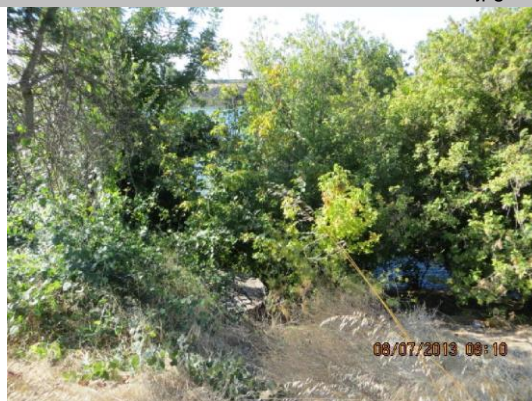
Photo 2 of 3 : UCIP_FA_2018_17287_29422.jpg

Gate valve in 5-foot diameter CMP riser on WS slope.

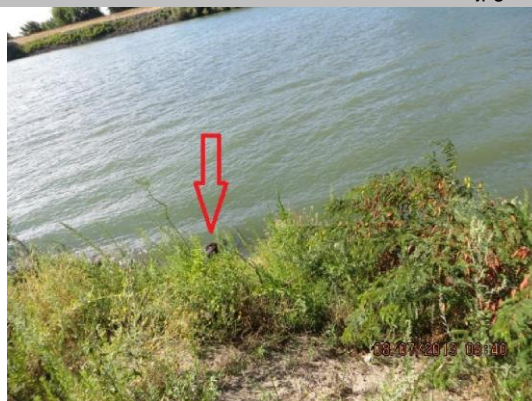
Photo 1 of 3 : UCIP_FA_2018_17343_29442.jpg

Pipe visible on WS toe.

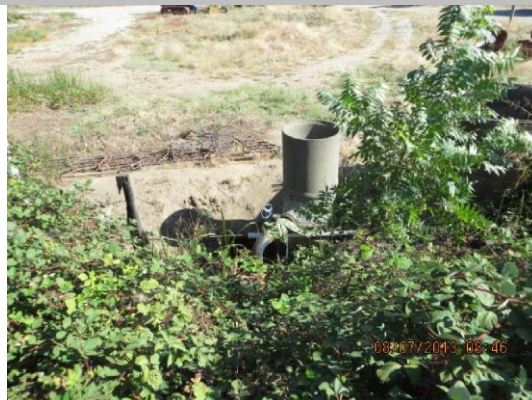
Photo 2 of 3 : UCIP_FA_2018_17343_29441.jpg

Pump, butterfly valve, vent, and concrete standpipe on LS toe.

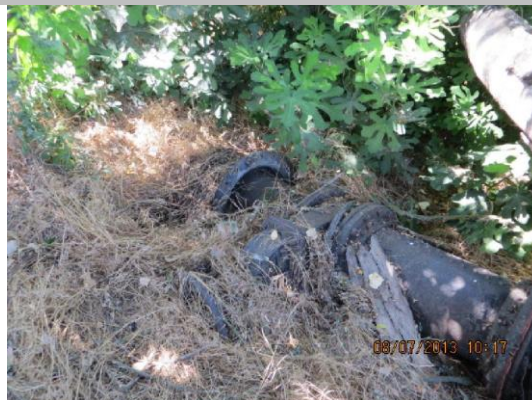
Photo 3 of 3 : UCIP_FA_2018_22712_38420.jpg

Gate valve on LS toe.

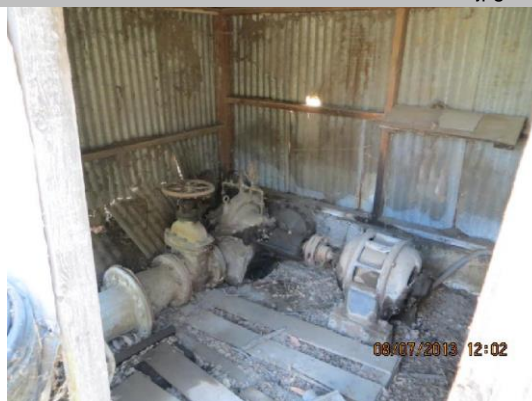
Photo 2 of 3 : UCIP_FA_2018_17385_29488.jpg

Pump and gate valve inside pumphouse on LS toe.

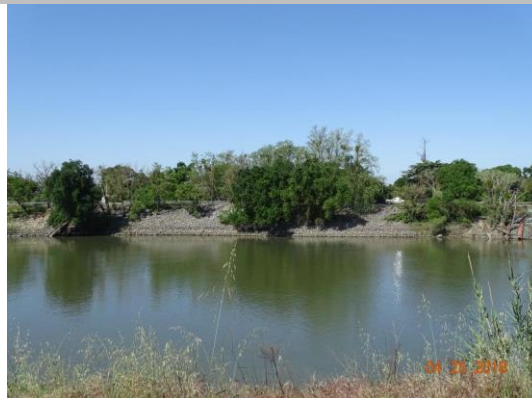
Photo 2 of 2 : FA_2018_RD0307_166_107_20180910_00029.jpg

LM Start	6.42	Rating **	A/W	Issue No.	107 (cont)	
LM End	6.55	Issue Type +	Ma	Location *	WS	
Category	Earthen Levee			GPS Latitude/Longitude		
				Start	End	
Item	Erosion / Bank Caving			38.431792 °	38.429923 °	
				-121.533353 °	-121.533235 °	
DWR ID	DWR_RD0307_01_s_2018_107					
Comment Code						
Inspector Comment						
This is to identify corrections to the USACE 2015 Erosion survey. The LMA repaired erosion sites in 2017.

RD307 Lisbon Unit 1 Issue 107 LM6.42-6.55 Erosion repaired picture taken from LB looking west.

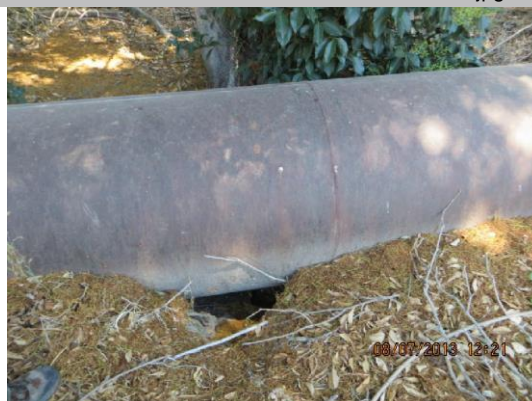
Photo 2 of 3 : UCIP_FA_2018_17404_29503.jpg

Animal activity/burrows under pipe on LS at various locations.

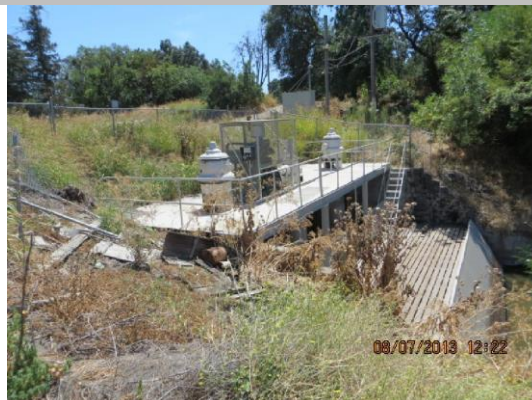
Photo 3 of 3 : UCIP_FA_2018_17404_29502.jpg

Pumping plant and trash rack off LS toe.

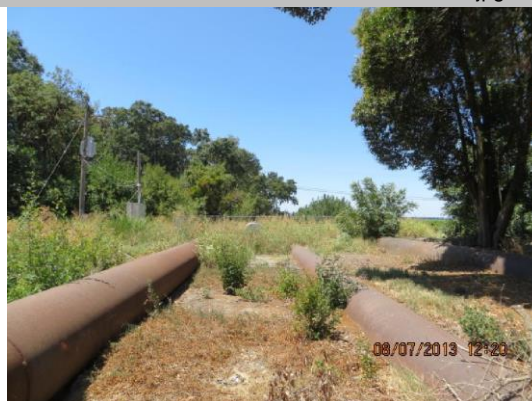
Photo 1 of 3 : UCIP_FA_2018_17406_29510.jpg

Pipes visible on LS toe.
